## Failure Processes in Penetrators With Shear-Control Grooves

by  
Stephen A. Finnegan  
and  
John Pearson  
*Research Department*

NOVEMBER 1984

This experimental study examines the failure processes in steel projectiles under target impact. This work was performed during Fiscal Years 1983 and 1984.

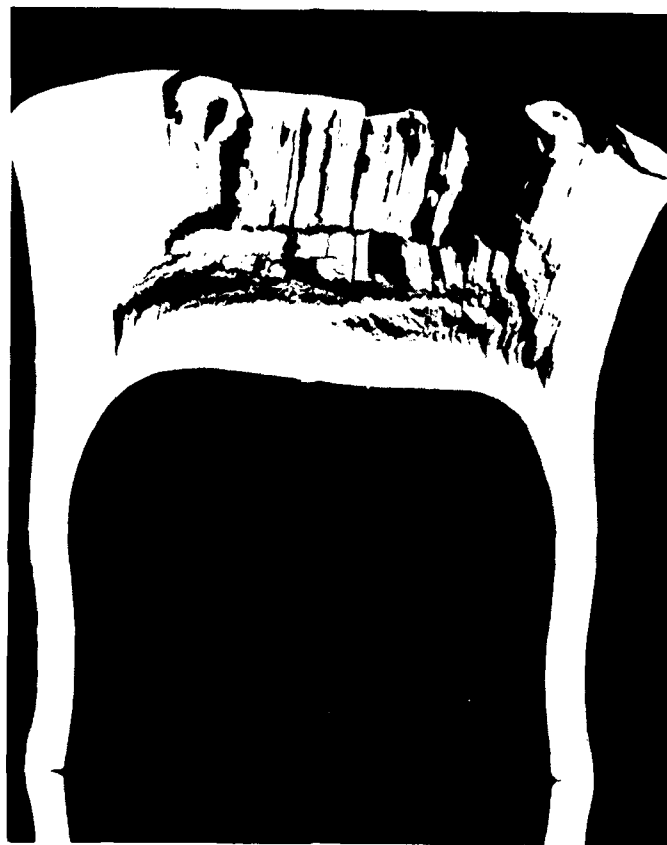
FIGURE 8. Section-View of Penetrator With Deep Control Groove Behind Primary Failure Zone (P-71D) After Impact on Steel Target at 2970 ft/s.

Figures 7 and 8 show penetrators which impacted at similar velocities of 2980 and 2970 ft/s, respectively. Both penetrators had grooves located 0.71 inch from the front end of the projectile and outside of the primary zone of failure. The penetrator of Figure 7 had a shallow groove, while the penetrator of Figure 8 had a deep groove. Although the buckling was somewhat greater for the deep groove, neither of these penetrators sustained shear fractures in the sidewall. As all of these figures show, the primary mode of failure for the penetrators which impacted thin steel targets was disintegration of the nose and not failure of the sidewall.

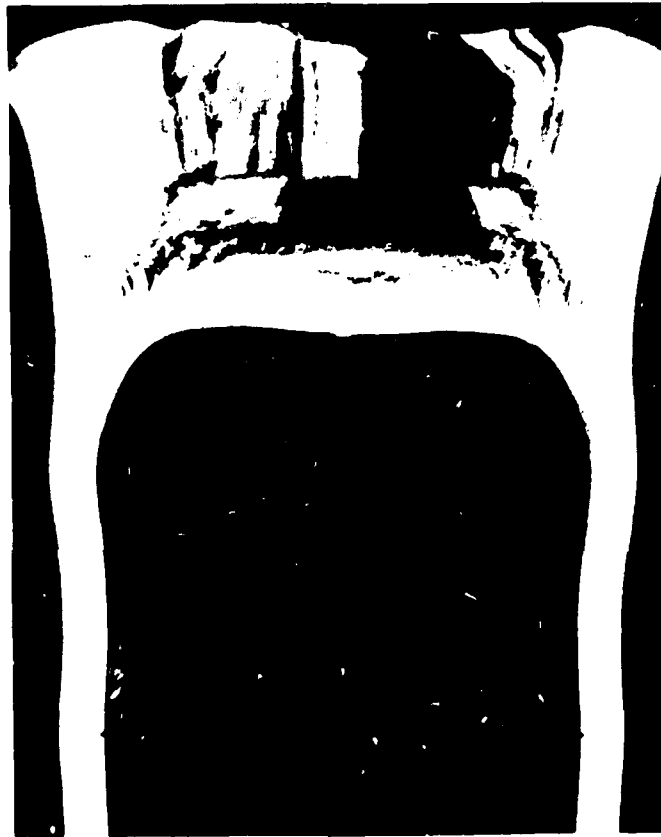
FIGURE 7. Section View of Penetrator With Shallow Control Groove Behind Primary Failure Zone (P-71S) After Impact on Steel Target at 2980 ft/s.

White-etching shear bands were identified both in the surface areas of the nose and in the bulged areas of the sidewalls. In both locations the shear bands were associated with the formation of shear fractures. Figures 9 and 10 are representative of the concentrated shear bands which formed along the outer edge of the projectile face. Figure 9 shows multiple bands as they appeared in a projectile which impacted at 2980 ft/s, while Figure 10 shows a single band formed on the opposite side of the same projectile (see Figure 7).

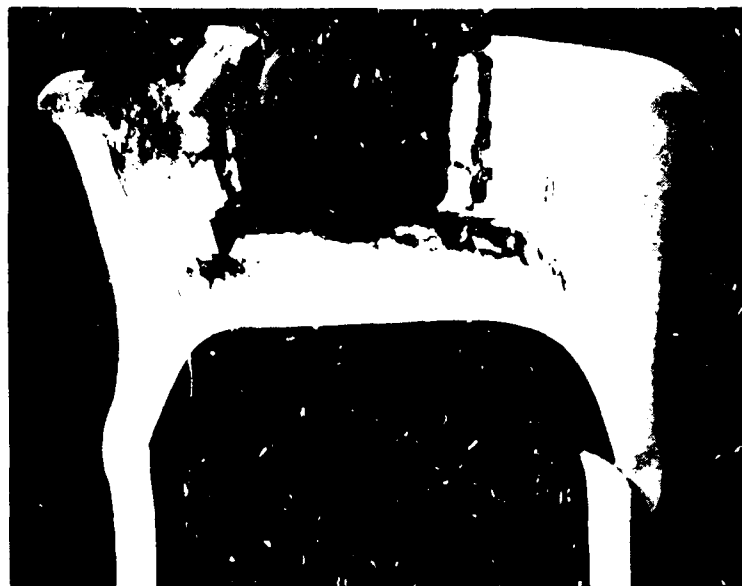
**FIGURE 6.** Section-View of Penetrator With Deep Control Groove in Primary Failure Zone (P-46D) After Impact on Steel Target at 2950 ft/s.

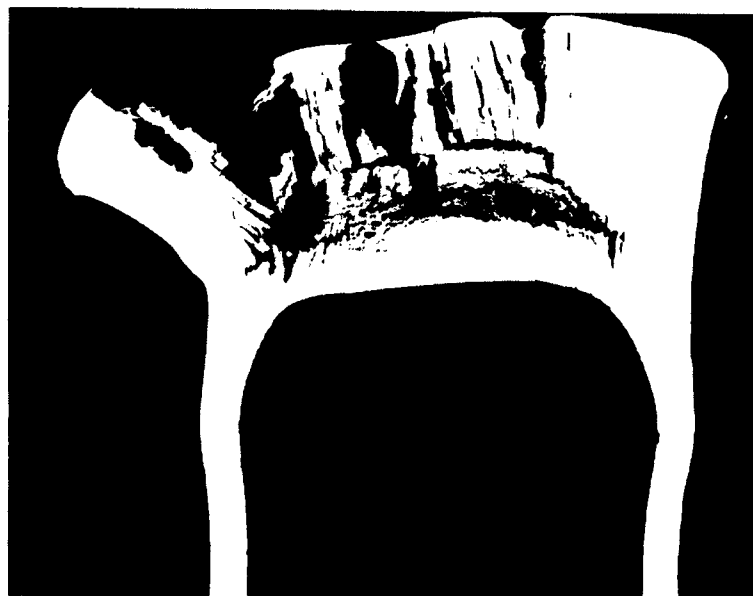
FIGURE 4. Section-View of Smooth-Wall (P-N) Penetrator After Impact on Steel Target at 2995 ft/s.

Figure 4, which is an axial cross section of the forward portion of a plain-wall penetrator (no grooves) which impacted at 2995 ft/s, shows the various failure patterns encountered. Nose damage includes (1) lateral bulging of the frontal portion accompanied by axially oriented tensile fractures, some of which radiate outward from the center of the nose and others of which appear as circular ring fractures, with both geometries occasionally terminating with a shear lip at the frontal surface; (2) shear bands along the outside edge of the frontal surface; and (3) a family of parallel tensile fracture surfaces identified as spall fractures, which resulted from stress wave reflections off the back surface of the nose. As many as five spall surfaces were found at the higher impact speeds, a process requiring very high-amplitude, short-duration stress transients.
